# Manhole Inspection Summary

Manhole # S21E\_\_031MH

Insp Date: **10/15/07 8:53 AM**

**Location** Address: **1900 PAYSON-MONROE**

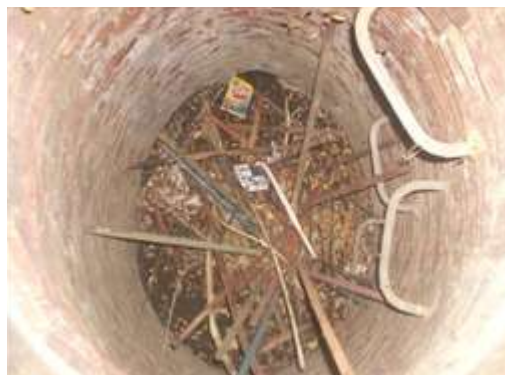
Top View

DEBRIS IN THE CHANNEL

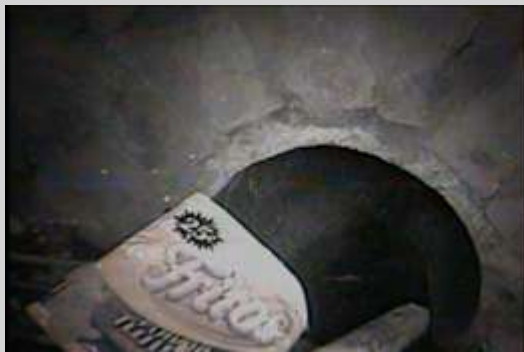
12 O'Clock Outflow

8 in. Circular Gravity Sewer  
Pipe Out @ 12 O'Clock

Deposits: ☐ None ☐ Mud ☐ Sludge ☒ **Debris** ☐ Grease

Silt Depth: **1** (in.) Deposits Extent: **Light**
